January 28, 2013

## **MEMORANDUM**

**SUBJECT:** Quarterly cap inspection at the San Jacinto River  
Waste Pits superfund site

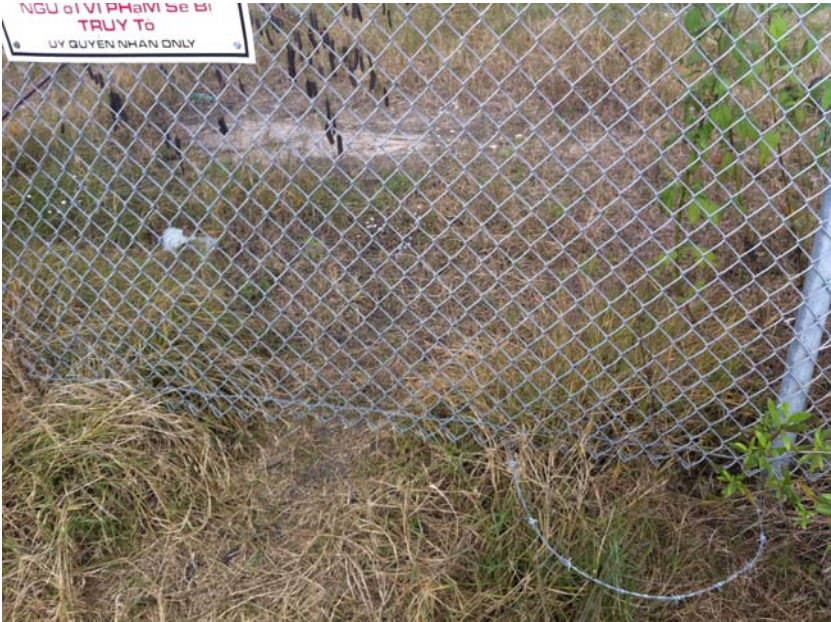
During the site visit it was noted that the Site security fencing visible and intact with the exception of one small area about 50 feet west of the southern gate (See attachment photo 1). This area of the security fencing displayed evidence of tampering where the barb wiring had been recently cut. In addition, to the fencing being cut, a well worn path leading up to the area was present with a hole at the bottom of the fencing big enough to allow an adult to crawl through underneath. Site signage placed along the fencing perimeter and signage placed along the armor cap was visible and intact.

Photo 1- View of Site perimeter fencing with evidence of tampering with barb wire cut.

Along the northwest corner of the site, just beyond the western berm area, it was noted that two small areas about 10 foot square where geotextile fabric was visible (See attachment photo 2). I have notified the respondents both verbal and in writing on January 28, 2013 of the areas needing further investigation.

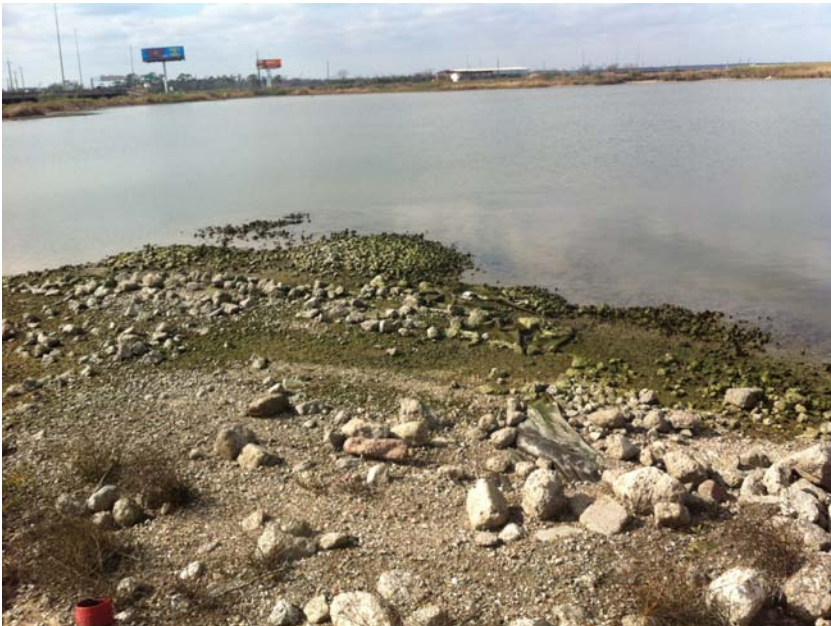
Photo 2- View of visible geotextile fabric along western berm in northwest corner of Site.

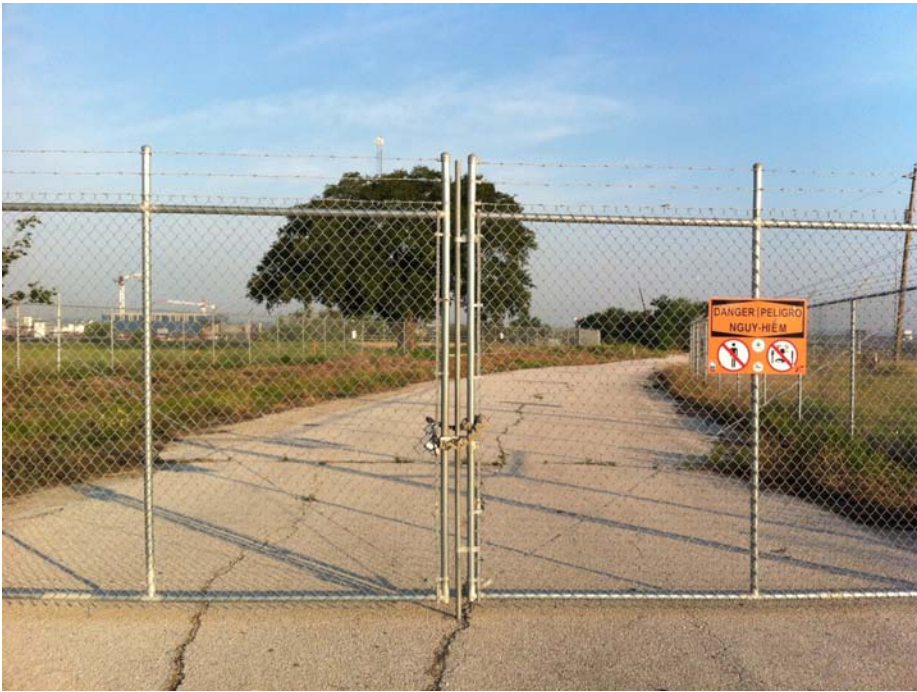
Photo 3- View of Site perimeter fencing East Gate, East of San Jacinto River

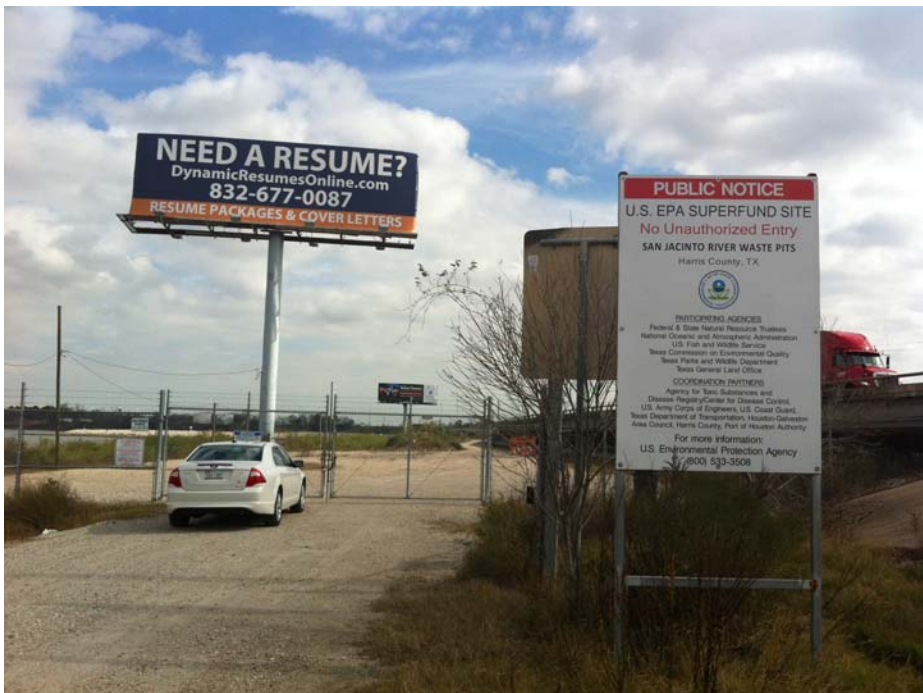
Photo 4- View of Site perimeter fencing Main Gate North along I-10, West of San Jacinto River

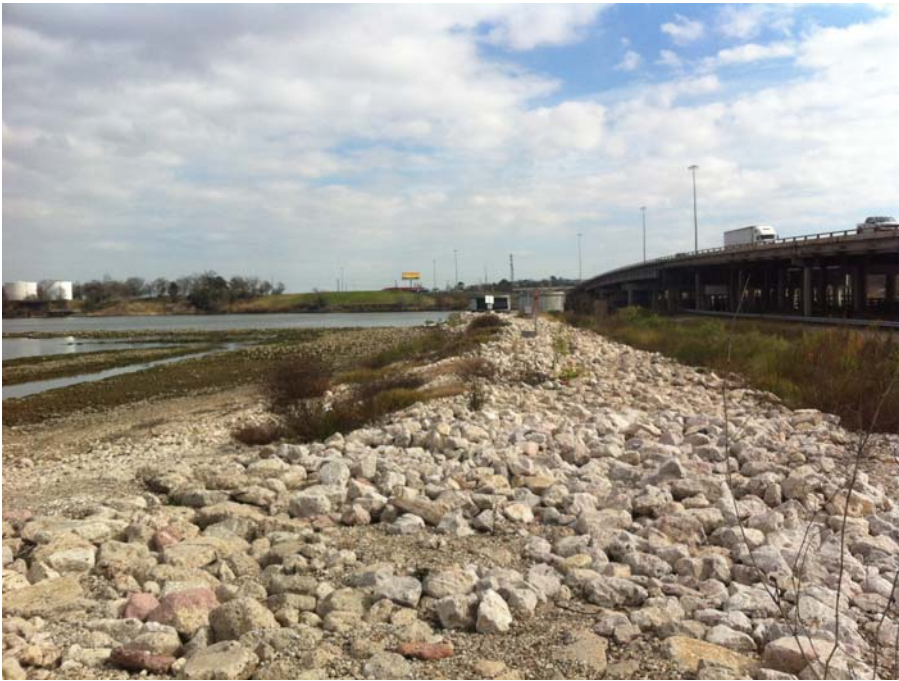
Photo 5- View of armor cap's southern berm and eastern impoundment North of I-10, West of San Jacinto River

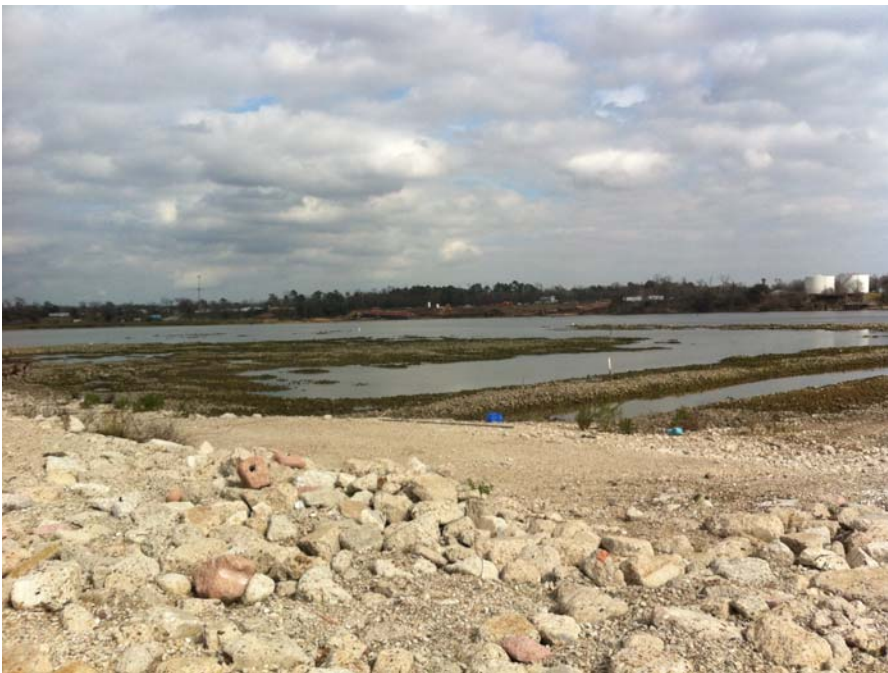
Photo 6- View of eastern impoundment of armor cap North of I-10

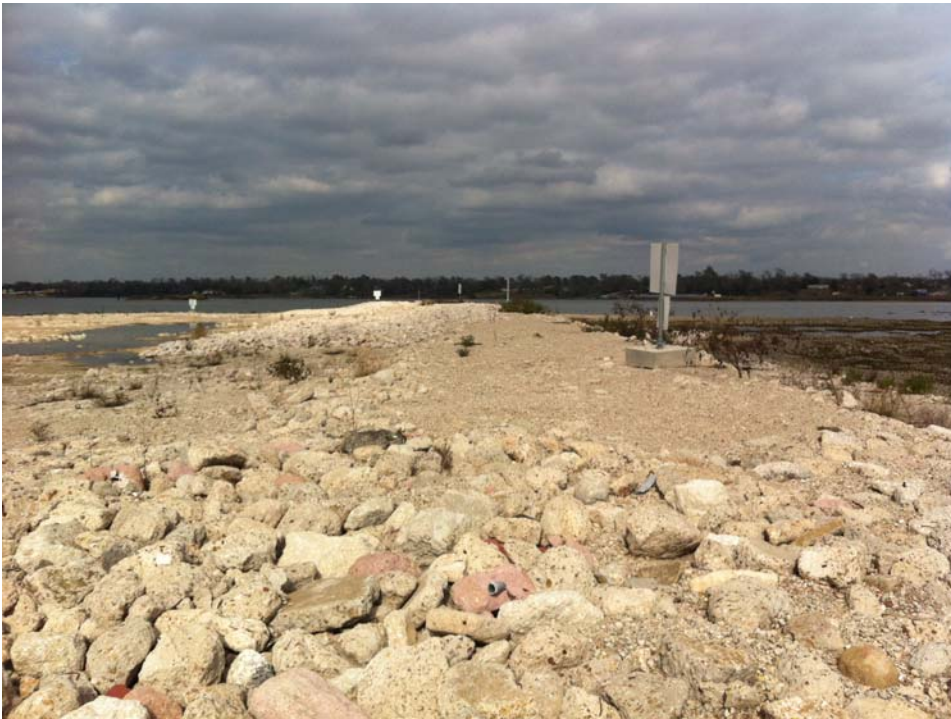
Photo 7- View of central berm with both western and eastern impoundments of armor cap North of I-10

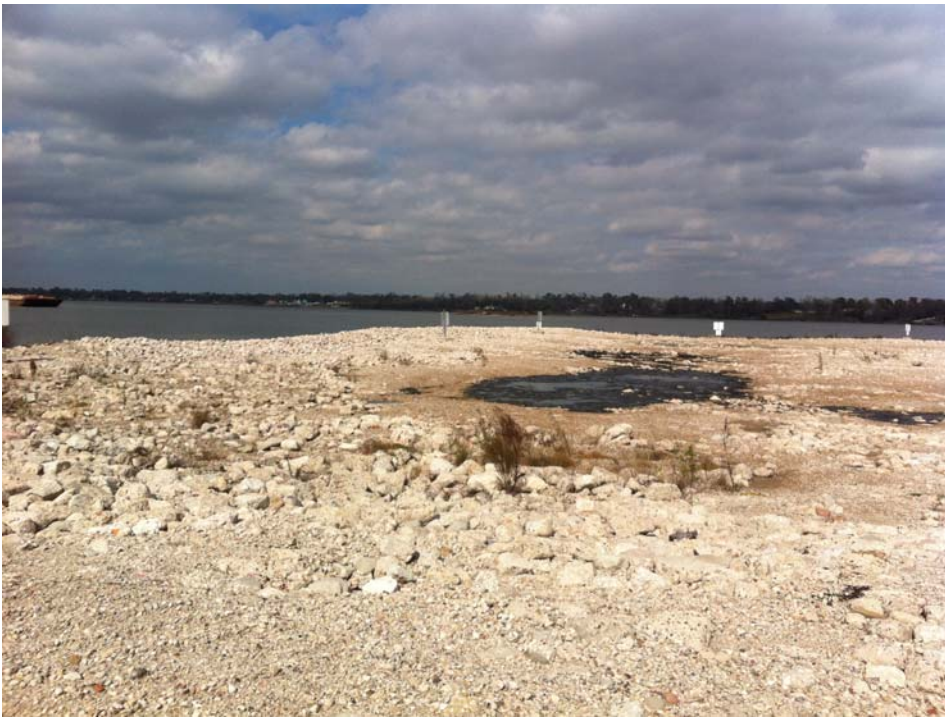
Photo 8- View of western berm and western impoundment of armor cap North of I-10

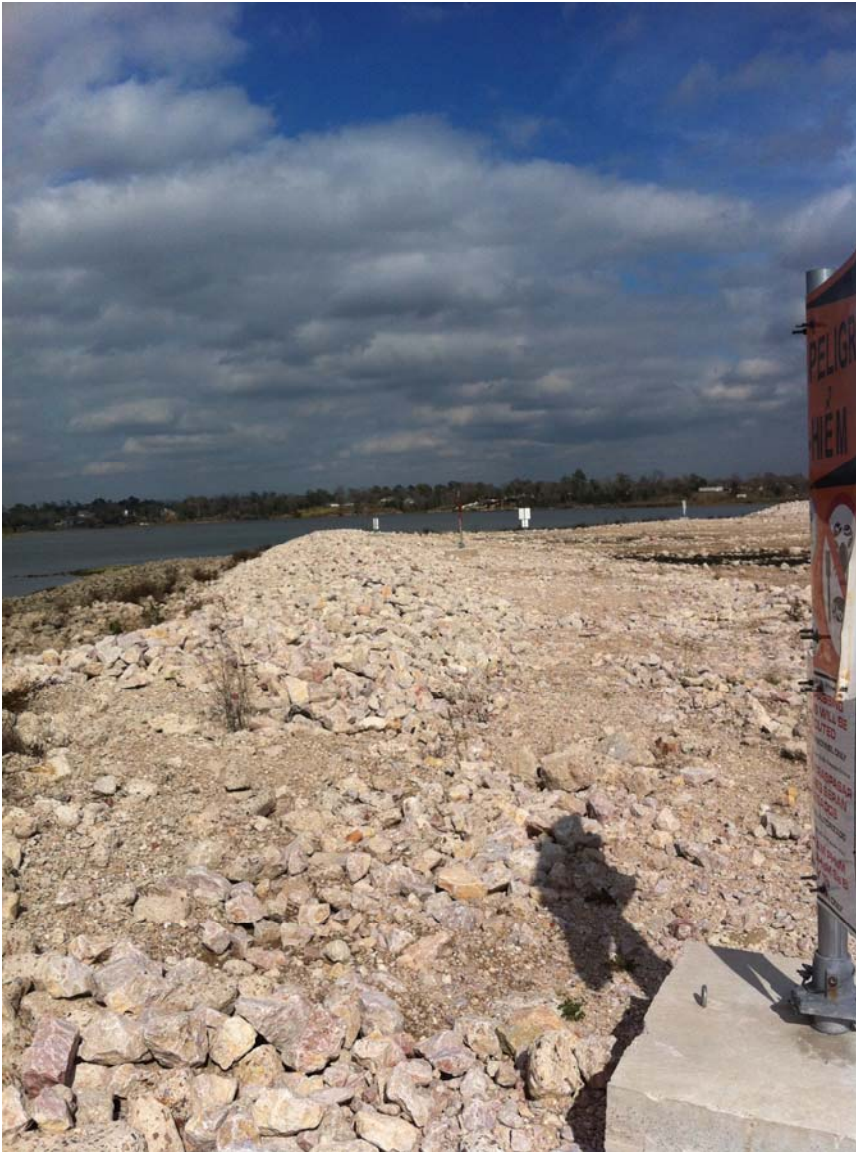
Photo 9- View of western berm and western impoundment of armor cap North of I-10
